Manhole Inspection Summary

Manhole # S05AA2015MH

Insp Date: **8/17/06 12:00 AM**

Location Address: **5913 KEY AVE**

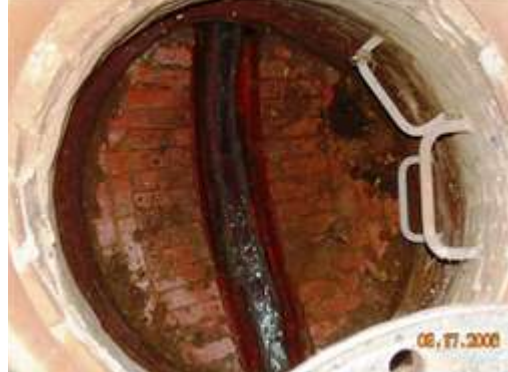
Top View

Frame Offset: **2** (in.) Condition: ☐ Sound ☐ Cracked ☒ **Leaks**

Chimney / Frame Adjustment ☒ Exists Material: **Brick** ☐ Parged Height: **6** (in.)
Condition: ☐ Sound ☐ Cracked ☐ Root Intrusion ☒ **Loose Brick** ☒ **Deteriorated**
Infiltration: ☐ None ☒ **Joint** ☐ Cracks ☒ **Mortar** ☐ Roots ☐ Wall

Frame leaks. Frame offset. Adjustment deterioration and loose brick. Adjustment and Corbel infiltration. Evidence of

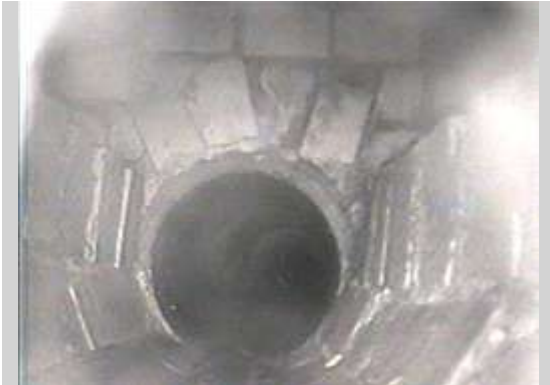
8 in. Circular Gravity Sewer Pipe Out @ 12 O'Clock

Infiltration: **Evidence** Pipe Seal Cond: **Unknown**

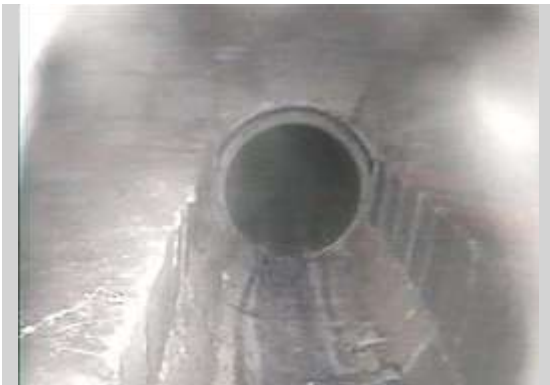
8 in. Circular Gravity Sewer Pipe In @ 6 O'Clock

Infiltration: **Evidence** Pipe Seal Cond: **Unknown**
